Duck Lake 2016 Aquatic Vegetation & Water Quality Report & 2017 Management Recommendations

October, 2016

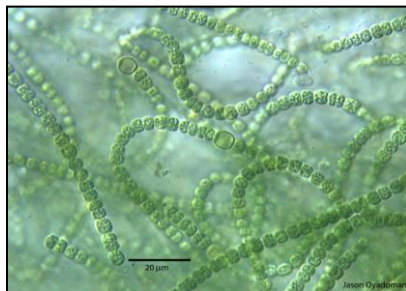
Figure 2. A Blue-Green Alga

The algal genera were determined from composite water samples collected over the deep basin of Duck Lake in 2016 were analyzed with a compound bright field microscope. **The genera present included the Chlorophyta (green algae; Figure 1): *Scenedesmus* sp., *Chlorella* sp., *Cladophora* sp., *Euglena* sp., *Haematococcus* sp., *Pediastrum* sp., *Gleocystis* sp., *Radiococcus* sp., and *Chloromonas* sp.** The Cyanophyta (blue-green algae; Figure 2): *Gleocapsa* sp., the Bascillariophyta (diatoms; Figure 3): *Synedra* sp., *Fragilaria* sp., *Navicula* sp., *Cymbella* sp., and *Tabellaria* sp. The aforementioned species indicate a diverse algal flora and represent a good diversity of alga with an abundance of diatoms that are indicative of great water quality. Photos of the general algae types are shown below.

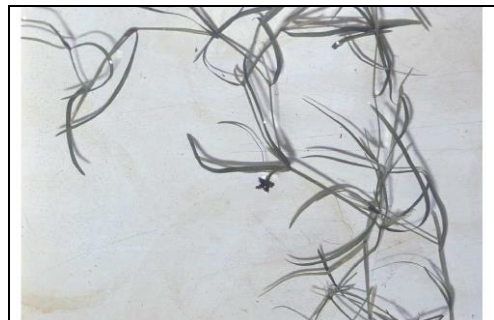
Figure 5. Water Star grass

Native aquatic vegetation is essential for the overall health of the lake and the support of the lake fishery. The whole-lake aquatic vegetation survey on May 10, 2016 determined that there were a total of 25 native aquatic plant species. These include 15 submersed species, 4 floating-leaved species, and 6 emergent species. The most common native aquatic plant species in 2016 included the submersed macro alga *Chara vulgaris* (Figure 4) and Water Star grass (Figure 5).

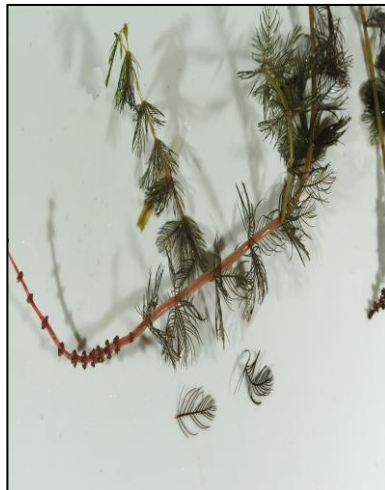
Figure 6. Eurasian Watermilfoil

Eurasian Watermilfoil (EWM) is an invasive, submersed aquatic plant (Figure 6) that spreads through fragmentation, seed dispersal, and underground stolons. A lake management plan study conducted by RLS in 2015 found that approximately 30 acres infested the lake.

The amount of EWM present in Duck Lake varies each year and is dependent upon climatic conditions, especially runoff-associated nutrients. 2016 was among the hottest year on record and many lakes experienced nuisance milfoil and algal outbreaks even despite two consecutive harsh winters. **The May 10, 2016 survey revealed approximately 15.0 acres of milfoil and 1.0 acres of Curly-leaf Pondweed (Figure 7) in the lake. On June 2, 2016, the milfoil and nuisance pondweeds were treated with Renovate OTF and Sculpin and Aquathol-K®, respectively. The treatment was very successful with only a few stems of EWM and few pondweeds in the treated areas remaining at the end of 2016.**

Due to the great overall depths of Duck Lake and limited areas with native aquatic vegetation in Duck Lake, the treatment of these species with aquatic herbicides is not recommended (one exception is the overgrowth of nuisance pondweeds and algae in a few select areas of the lake). The plan for 2017 includes the use of high dose systemic aquatic herbicides for effective Eurasian Watermilfoil control. The nuisance Pondweeds will respond well to Aquathol-K® at 2-3 gallons per acre.
